THE OFFICIAL MOUTHPIECE OF THE AQUAVIC IONISER USER'S GROUP

Vol. 17 no.1 Winter Edition 2017

From the Director:

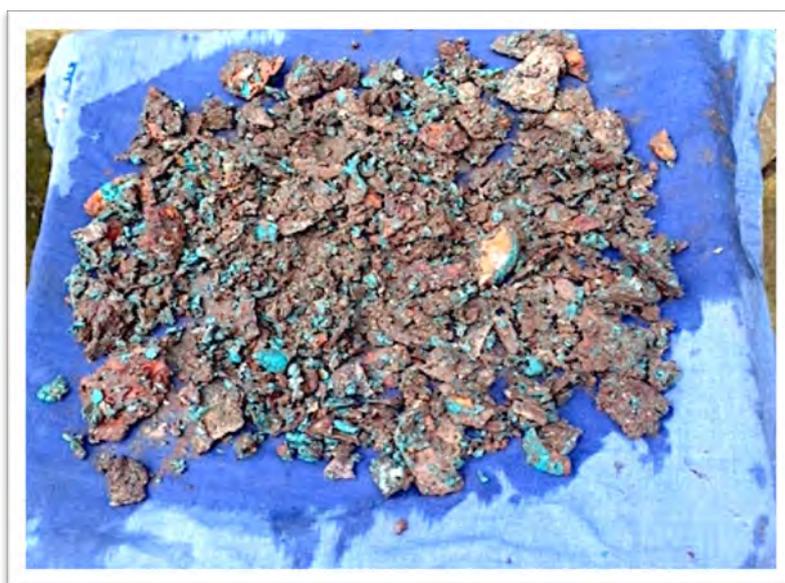
Pic:5

Pic 5: shows the sum total of the ‘crud’ that was removed from 6 pairs of badly fouled electrodes which were allowed to run on a dead water for a period of around 3 months. Suffice to say that what was left of the electrodes was not worth saving, and six new pairs had to be installed to restore the status quo.

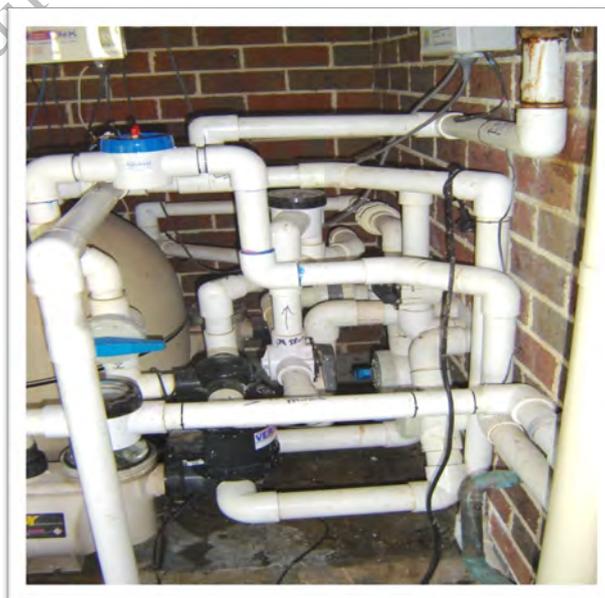
Pic 5: Spaghetti Junction!

We have done many site visits over the years and one thing that continues to bug me is unidentified pipework. In most cases the pipe runs can be identified by instinct and trial and error, but once the pipework goes subterranean, the task can become quite time-consuming – or, in some extreme examples, the pipework is so incredibly complex that it's virtually impossible to identify its function. **Pic 5** is one such example and arguably the most complex that I've come across in two decades – and I've seen a few.

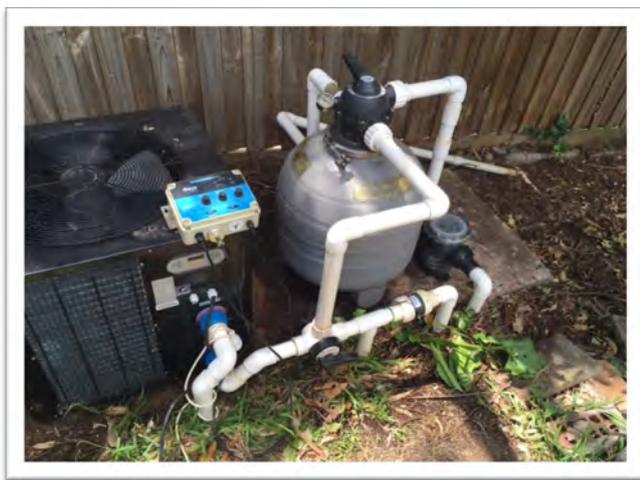
Pic 6: is an example of the subterranean version. It clearly illustrates a simple system “as found” during a site visit, and, as can be seen, there are 5 pipes that disappear into the ground – and none have any identification! Reading from left to right, the first pipe, which is connected to the heater, disappears into the ground. It should be heading back to the pool, but...? The second pipe, which is just past the 3-way valve with the black locking ring, also simply disappears into the ground going God knows where.

The third pipe, which is downstream of the ioniser’s flowcell, also disappears into the ground, but almost certainly serves the pool’s jets. And as the next pipe is connected to the suction side of the pump, it can safely be assumed that it is connected to the skimmer box. The last, that angled pipe behind the filter, is the filter’s backwash pipe and probably goes to sewer (or possibly storm water) and is of no concern. But once the overburden and detritus was removed, the picture became very much clearer. As can now be seen in Pic 7, the heater pipe, which appeared to just disappear in the terra firma, actually does a 90 deg, turn and TEEs into the return-to-pool pipe upstream of the flowcell. This is but a very simple example of what is out there, but the moral of the story is identify your pipework. If you can’t, send me a pic.
