THE OFFICIAL MOUTHPIECE OF THE AQUAVIC IONISER USER'S GROUP

Vol. 15 no.1 Autumn 2015

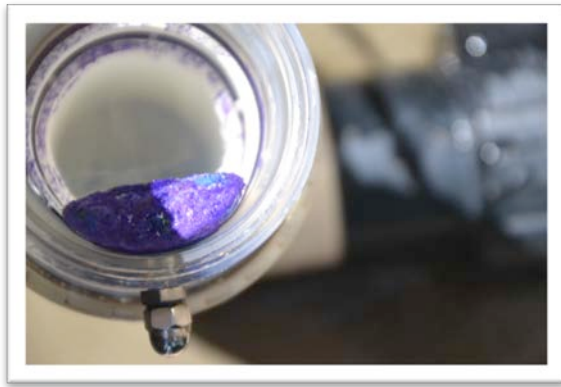
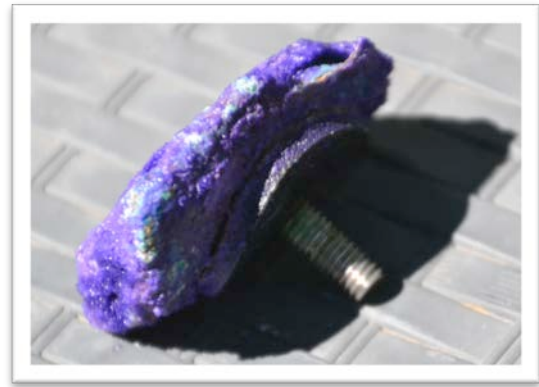
On a lighter note, a customer recently complained that his ioniser's electrodes had turned purple (see pic below) a condition with which I was not familiar, but our consulting chemist "*The Guru*" was. It is a condition which would have also rung bells with students of the English Monarchy, particularly so with Mad King George III.

What did this customer's electrodes and Mad King George have in common? Well the answer is the colour purple. In the case of Mad King George, he presented with water "samples" that turned purple when exposed to sunlight, and in the case of my customer, his swimming pool ioniser's electrodes turned purple after exposure to sunlight.

In people, this is a medical condition called “*porphyria*” but in our customer’s case, it was to do with sunlight, the 40 kgs of salt added to 20,000 litres of pool water, and the silver component in the electrodes – and the perfect Segway to the next item.....

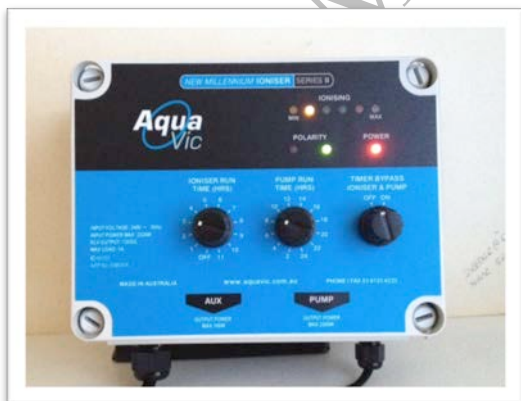
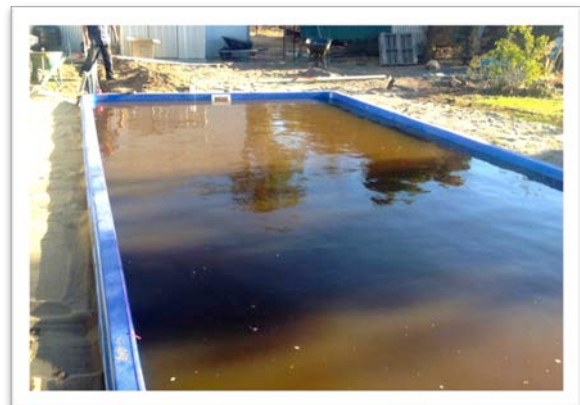
When following up with the owner of the purple electrodes above, it transpired that he was concerned about the apparent low conductivity of the pool water as shown by a yellow LED on the IONISING array (see pic left below) and so added some pool salt. In a brand new, or recently refilled pool with good quality town water, this is standard practice, but on older pools, unless a large percentage of the water has been lost and replaced with fresh* the conductivity has been well and truly established. In fact, the older the water is, the higher the concentration of dissolved solids, the higher the conductivity is more likely to be.

Generally speaking, if your ioniser is showing signs of failing ionising capability, the first step always is to check the condition of the electrodes and the cleanliness of the terminals. If they’ve burnt away to less than the size of the black rubber sealing washer, then a new pair is required. In many pools filled or topped up or refilled with water of indifferent quality (see pic right below for an extreme example) electrodes can form a significant layer of scale which, if allowed to go unchecked, forms a dielectric, or insulating layer, which severely retards the free flow of current from one electrode to the other.

But before you even contemplate dumping many kilos of pool salt into what is already water of ideal conductivity, clean both electrodes back to bare metal, and *then* check the IONISING array. If there is no appreciable shift to the right, then you can add salt – but never more than about 2.0 kgs, per serve – and allow plenty of time for it dissolve and thoroughly circulate. If it fails to make a difference, give us call. BTW, if any of the “Ionising” LED’s are on, the system is working and needs no further assistance.

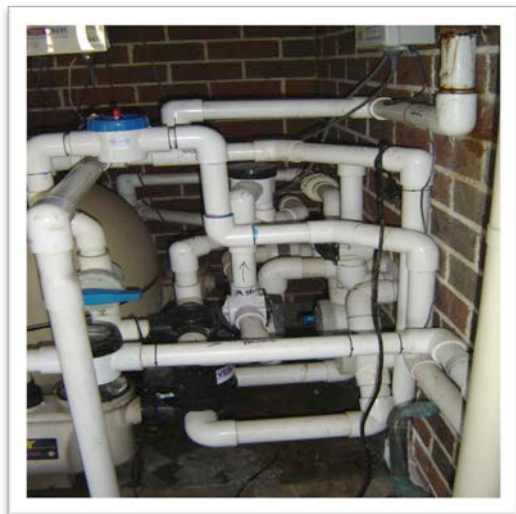
The pipework in the LH pic, the defending champion for the title of "*Spaghetti Junction*" is yet to be displaced by any other system that we've come across, but at least the pipe runs are vertical, parallel and horizontal. I wonder if it will ever be beaten for sheer complexity of plumbing on what is after all, an indoor domestic pool.

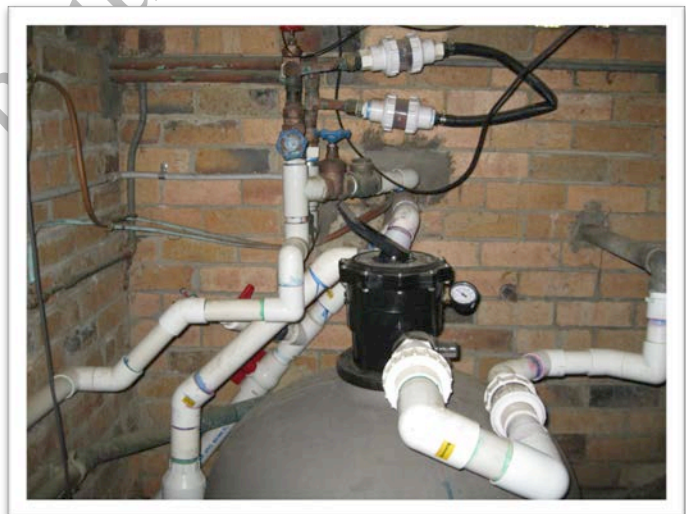
The RH pic below takes the prize for the greatest mix of pipe types (copper, PVC and black polypropylene pipe) and fittings (bronze gate valves and check valves, PVC check valves, Tees, bends, elbows, joiners that I have ever seen – and that's only what's in the photo. Note particularly the kink in the black poly pipe connecting the two check valves (top, slightly right of centre) whose function is a mystery. My guess is that the flow rate through the black poly pipe is so restricted that the check valves are superfluous anyway.
