THE OFFICIAL MOUTHPIECE OF THE AQUAVIC IONISER USER'S GROUP

Vol. 15 no.1 Autumn 2015

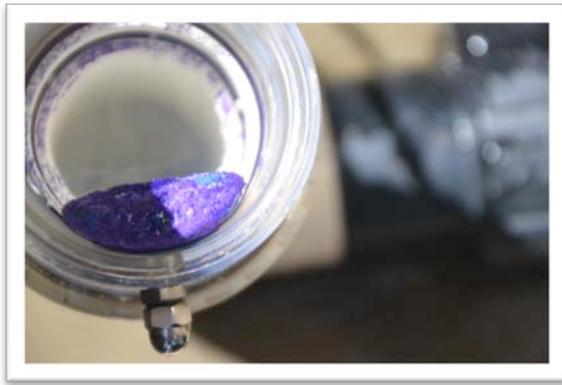
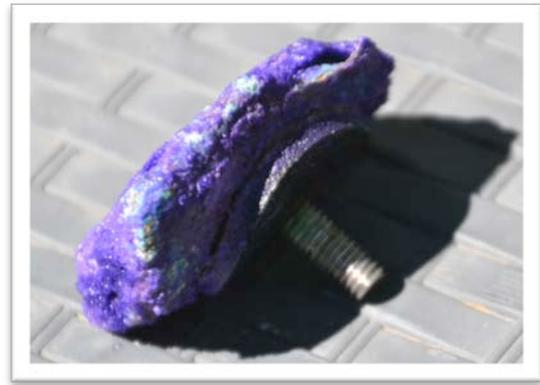
On a lighter note, a customer recently complained that his ioniser's electrodes had turned purple (see pic below) a condition with which I was not familiar, but our consulting chemist "*The Guru*" was. It is a condition which would have also rung bells with students of the English Monarchy, particularly so with Mad King George III.

What did this customer's electrodes and Mad King George have in common? Well the answer is the colour purple. In the case of Mad King George, he presented with water "samples" that turned purple when exposed to sunlight, and in the case of my customer, his swimming pool ioniser's electrodes turned purple after exposure to sunlight.

In people, this is a medical condition called “*porphyria*” but in our customer’s case, it was to do with sunlight, the 40 kgs of salt added to 20,000 litres of pool water, and the silver component in the electrodes – and the perfect segue to the next item.....

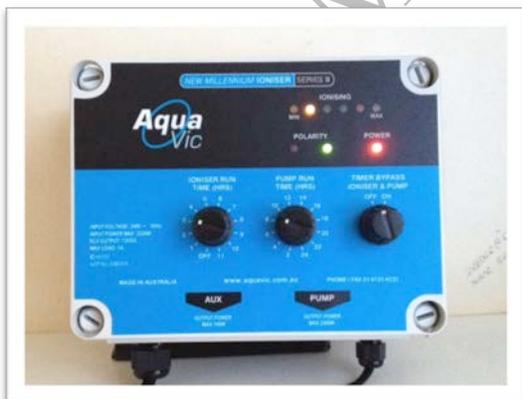
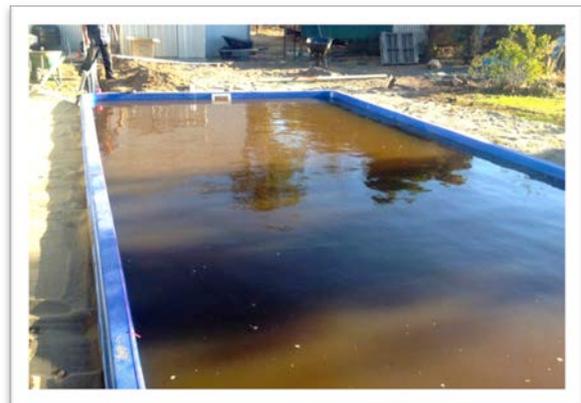
When following up with the owner of the purple electrodes above, it transpired that he was concerned about the apparent low conductivity of the pool water as shown by a yellow LED on the IONISING array (see pic left below) and so added some pool salt. In a brand new, or recently refilled pool with good quality town water, this is standard practice, but on older pools, unless a large percentage of the water has been lost and replaced with fresh* the conductivity has been well and truly established. In fact, the older the water is, the higher the concentration of dissolved solids, the higher the conductivity is more likely to be.

Generally speaking, if your ioniser is showing signs of failing ionising capability, the first step always is to check the condition of the electrodes and the cleanliness of the terminals. If they’ve burnt away to less than the size of the black rubber sealing washer, then a new pair is required. In many pools filled or topped up or refilled with water of indifferent quality (see pic right below for an extreme example) electrodes can form a significant layer of scale which, if allowed to go unchecked, forms a dielectric, or insulating layer, which severely retards the free flow of current from one electrode to the other.

But before you even contemplate dumping many kilos of pool salt into what is already water of ideal conductivity, clean both electrodes back to bare metal, and *then* check the IONISING array. If there is no appreciable shift to the right, then you can add salt – but never more than about 2.0 kgs, per serve – and allow plenty of time for it dissolve and thoroughly circulate. If it fails to make a difference, give us call. BTW, if any of the “Ionising” LED’s are on, the system is working and needs no further assistance.

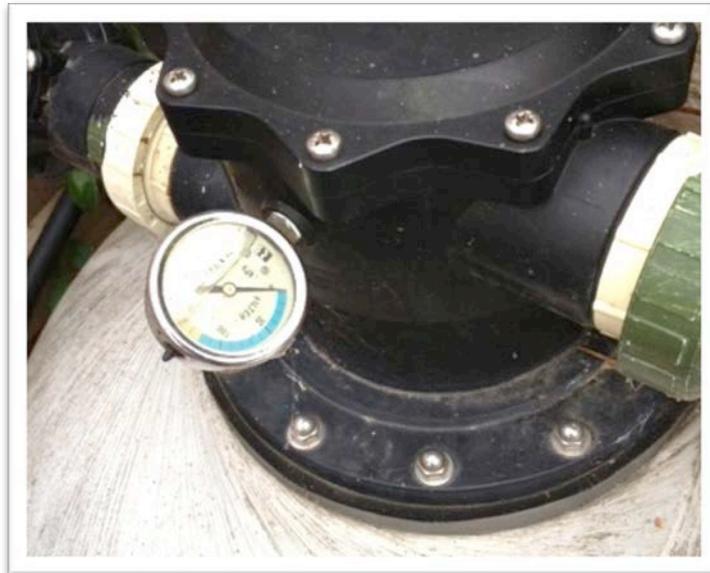
Whilst on the subject of filters, let's not forget the most ignored, neglected and misunderstood piece of equipment on your pool's filtration system – the pressure gauge. See pic below for a typical example. Contrary to popular belief, it hasn't been put there simply to plug a hole. It serves a very valuable function, and that is as a filter condition monitor. As the filter progressively removes suspended matter from the water, so the back-pressure will gradually rise until it gets to a point where the flow is dramatically reduced, or ceases altogether. If running a cartridge filter, you need to remove and clean the filter cartridge, or replace it. If a sand filter, it needs to be backwashed. In extreme cases, you can actually see the filter body expand when the pump starts.

How do you know when to service the filter? The first thing you do is to make a note of the pressure gauge reading with a freshly cleaned filter (with the pump running of course). A texta mark on the glass will help to jog the memory - but make sure that the glass is secure and not able to rotate in the housing. Then, as a “rule of thumb” whenever the pressure rises to about 50 kPa higher than the “clean filter” mark, then it's time to clean it.

It is the pressure gauge that dictates the frequency of cleaning, not the calendar.
